ETO ORDNANCE TECHNICAL INTELLIGENCE REPORT NO. 177

SUBJECT: German Heavy Semi-Trackted Recovery Vehicle Sd. Kfz. 9

Observations by: Capt. W. G. Fielding and T/Sgt. J. C. Holman, Ord. Tech.
Intell. Team No. 9.

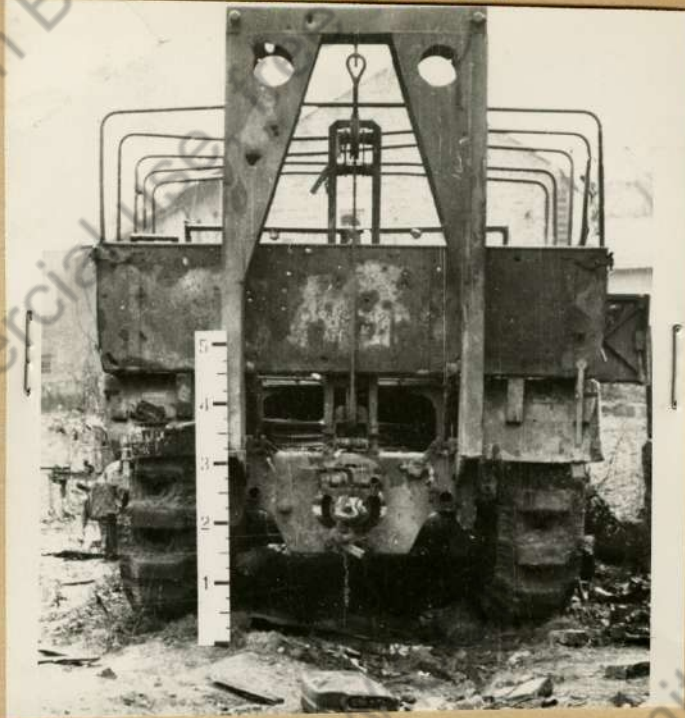
The frame is raised and lowered with the winch by running the winch cable over a pulley mounted on a vertical framework at the rear of the body (Photo #1). A hook to engage the eye of the cable is attached to the free end of the frame.

Photo No. 1.
Rear of semi-tracked
recovery vehicle
showing frame of
anchor in vertical
traveling position.
Note pulley on
vertical framework
for raising and
lowering frame.

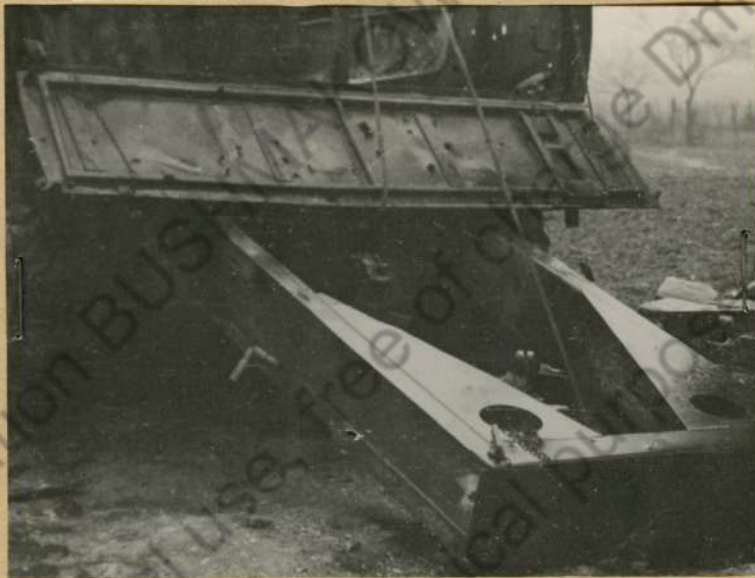
Photo No. 2
Frame lowered
into position
for recovery.
Spade is not
attached.

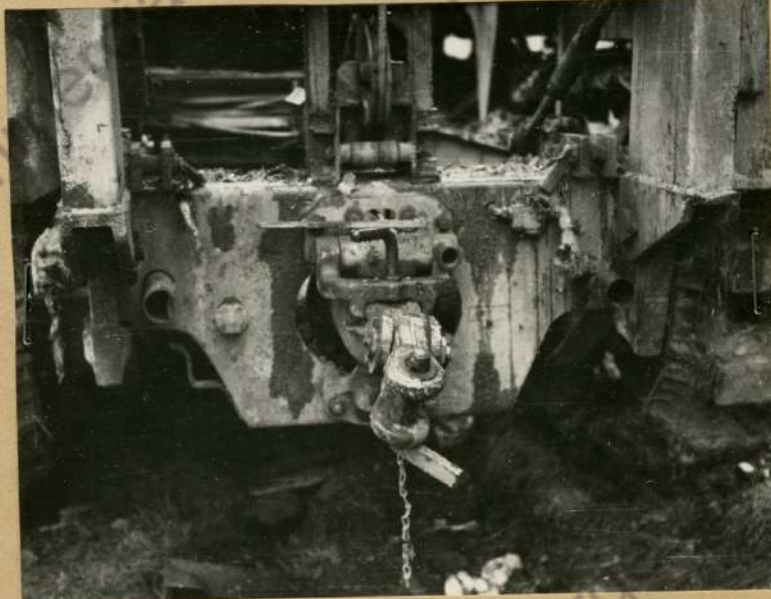
Photo No. 3
Hinged end of
frame and towing
pintle. Note extra
clevises near ends
of frame.

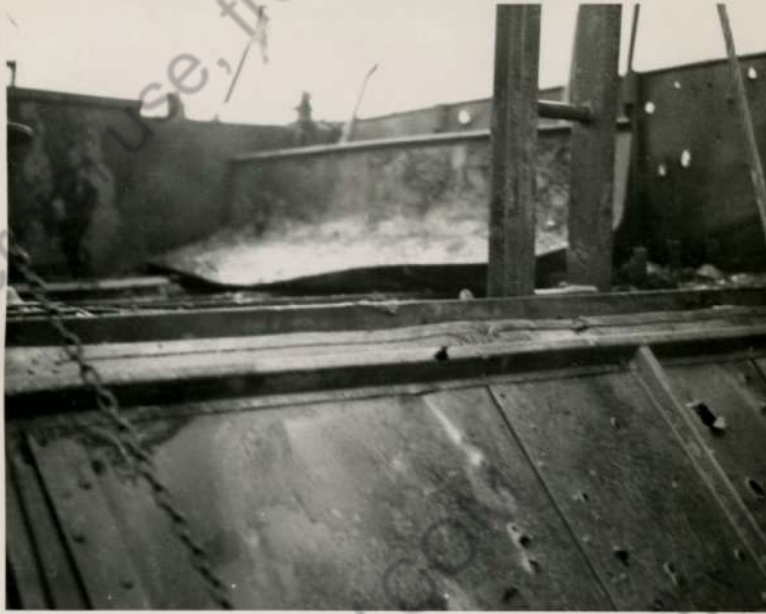
The frame and spade at the rear of the vehicle serve as an anchor when winching heavy loads. (Special hollow steel chock blocks are also supplied to be used at the rear of the tracks). The hinged frame is rectangular in shape and consists of three pieces of channel-section steel, two longitudinal and one transverse, reinforced by triangular plates (Photos #1 and 2). The open end of the frame is hinged to reinforced ends of the chassis frame (Photo #3). The spade is attached to the free end of the frame by two removeable pins. The spade is shown in Photo #4.

Photo No. 4. Spade as found stowed in vehicle. Base of framework for pulley is in foreground.

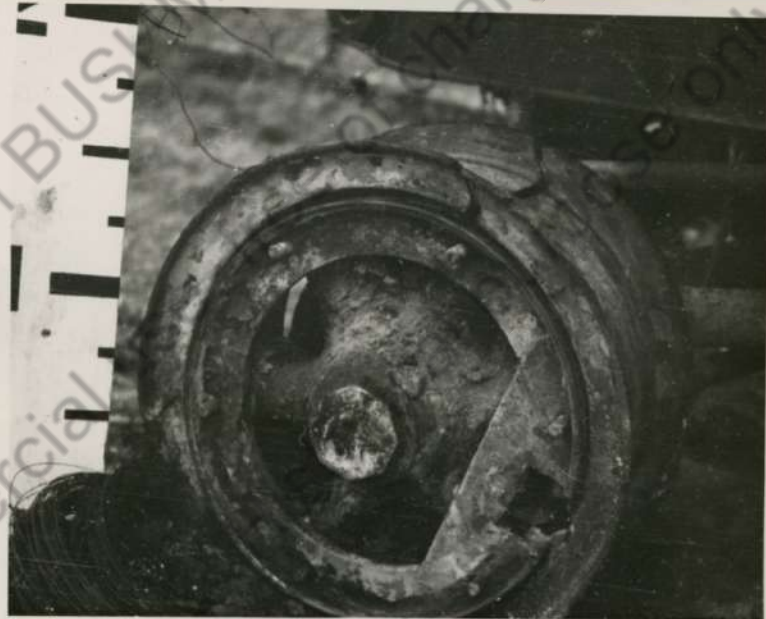
A three-piece rim is used on the front wheels (Photo #5). It is held in position by a heavy steel retaining ring mounted on six studs.

Photo No. 5. Three-piece rim on front wheel.
