ETO ORDNANCE TECHNICAL INTELLIGENCE REPORT

NO. 314)

SUBJECT: French R35 Tank Chassis Used as Carrier for German 8 cm. s.GW. 34 Mortar

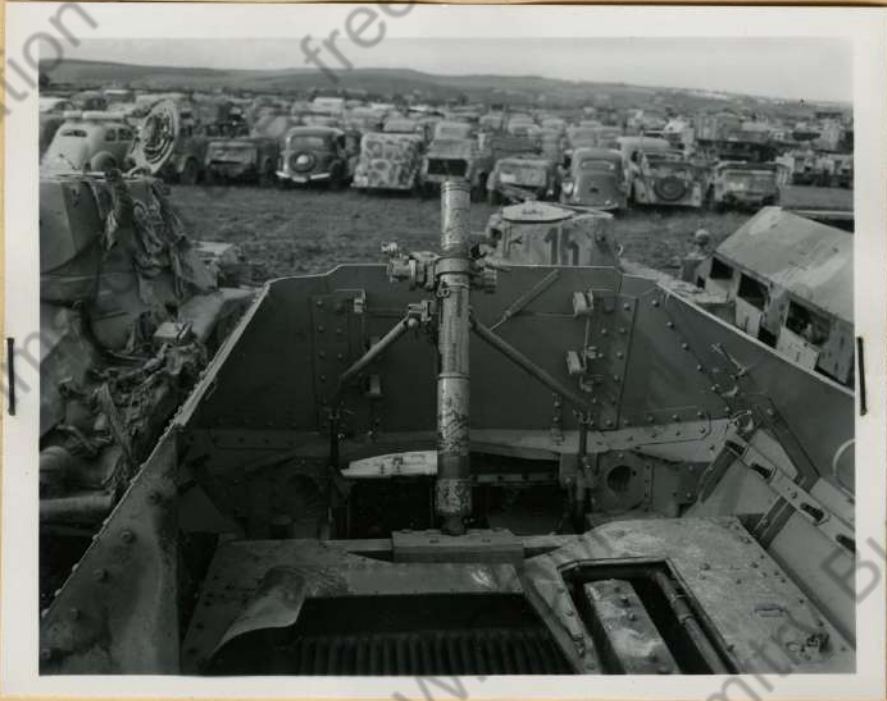
Photo No. 4

Rear view of mortar and fighting compartment.
Note arrangement of bipod legs and rack and pinion mechanisms.

The fighting compartment includes the space formerly occupied by the turret and the space above the engine compartment at the rear of the chassis. (Photos 3 and 4). The mortar is mounted at the front to fire forward. The front of the compartment is not separated from the driver's compartment, the driver entering from the rear.

The mortar tube rests on a base plate bolted to the top of the engine compartment (Photo 3). The bipod retains the normal cross-leveling, elevating and traversing mechanism, but the legs have been extended and are attached to rack and pinion mechanisms which permit additional elevation, traverse, and leveling adjustments (Photos 4 and 5). The mortar was equipped with a collimator mortar sight RA35.
