ETO ORDNANCE TECHNICAL INTELLIGENCE REPORT NO. 190

SUBJECT: German Mark III Tank Chassis used as Cargo Vehicle.

Observations by: Lt. J.F. Eppes, Ord. Tech. Intell. Team No. 3.

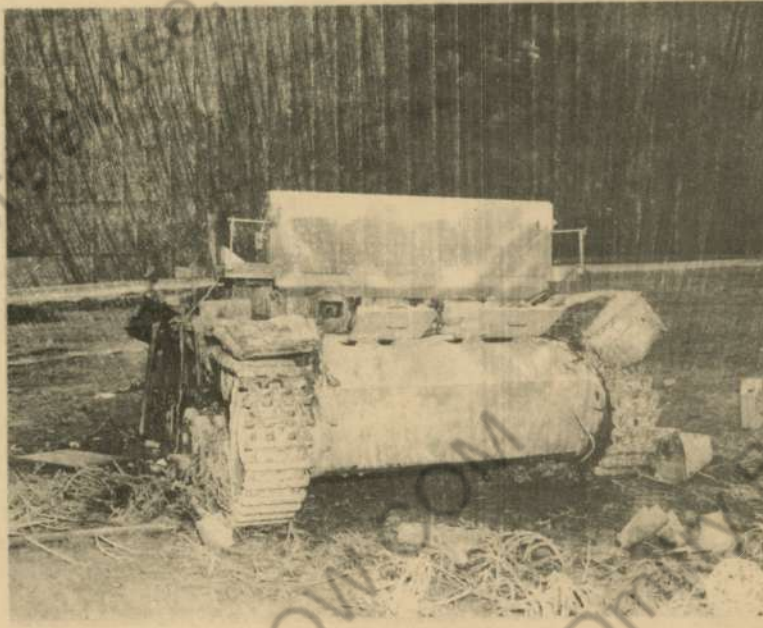
Figure No. 1: Front view. Note brackets on either side of box, mounted on superstructure

The cross pieces of the frame base are extended 12 ins. beyond the sides of the box and form the bases of 12 inch square carrying brackets. (See Figure No. 1, Appendix "A")

A triangular bracket having a horizontal plate with a 4 inch diameter hole in it is mounted on each side above the track guard and just to the rear of the superstructure side plate. These brackets may have been used to mount a vertical boom for a hoist. However, no equipment other than two pulleys was found with the vehicle.

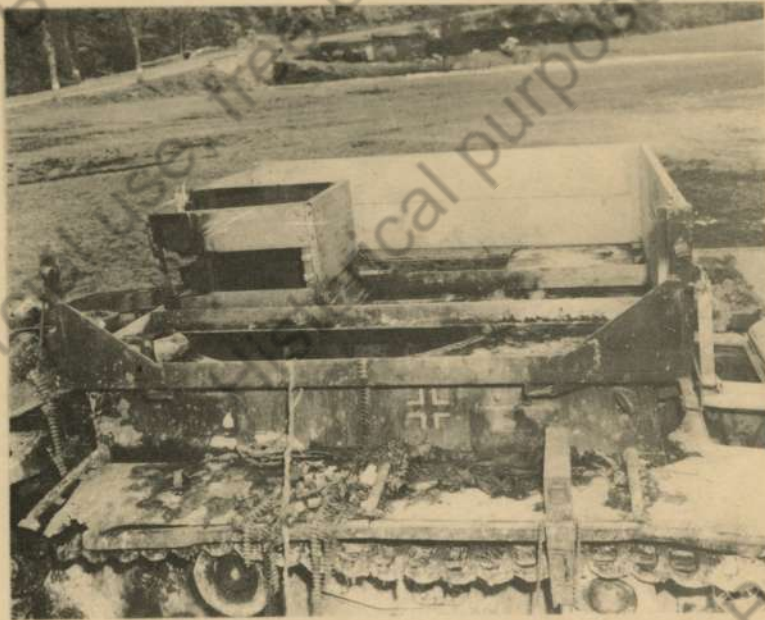
Figure No. 2: Close-up of box showing construction. Note attachment of longitudinal pieces to turret ring.

Construction of the frame is shown in Figure No. 2, Appendix "A". It is made of pieces of 1- $\frac{1}{2}$  inch x 4 inch angle iron. The two center longitudinal pieces are spaced 25 ins. apart and are fastened to the turret ring with four steel cleats. The outside corners of the frame base are braced with pieces of steel channel section which are welded to the bottom of the frame and bolted to the superstructure top plate. Each corner upright is strengthened with two gusset plates welded to the base.

The smaller inside box is 34 ins. long, 25 ins. wide, and 21 ins. deep. No floor is provided in this box, thus indicating its possible use as a hatch. The space between the center longitudinal pieces not taken up by the box is covered over with a removable steel plate, and the spaces on the sides are fitted with 1- $\frac{1}{2}$  inch thick wood flooring. The wood flooring is also removable.
